Kysor On/Off Diagnostic Guide

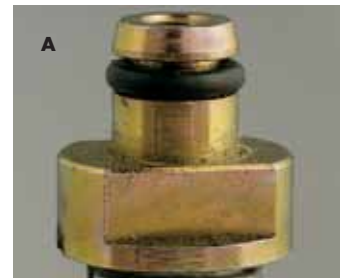
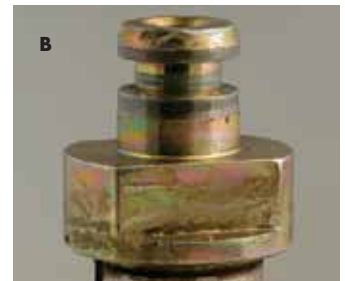
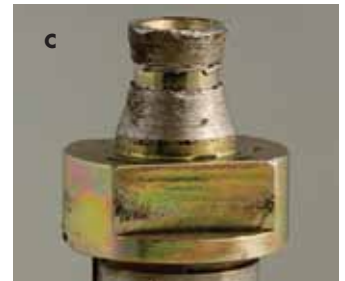
Damage to the rear of the piston rod (center shaft) and rear O-ring is usually caused by worn or damaged pulley hub bearings. This may first be noticed as an air leak at the rear of the clutch.

The rear portion of the piston rod enters into the front of the pulley hub shaft. Bearing wear or damage in the pulley hub may cause the pulley to not run true on the shaft. Bearing wear can cause damage to the rear O-ring and eventually the piston rod. (Figure 6) There should be no play in the pulley hub bearings. Check for scuffed plating on the piston rod around the O-ring area. Check for worn metal at the rear of the piston rod. If the metal is not damaged, the clutch can be reused.

Figure 6 Oring area of new piston rod (Figure A), minor damage at rear of piston rod showing scuffed plating serviceable with repair kit (Figure B), and severe damage to rear of piston rod showing worn-away metal, not serviceable. (Figure C)

Always determine and correct the cause of failure. Inspect and make any pulley hub repairs or replace the pulley hub as required if worn or damaged. Pulley hub bearing kits are available for service.
