On/Off Fan Drive Diagnostic and Service Guide

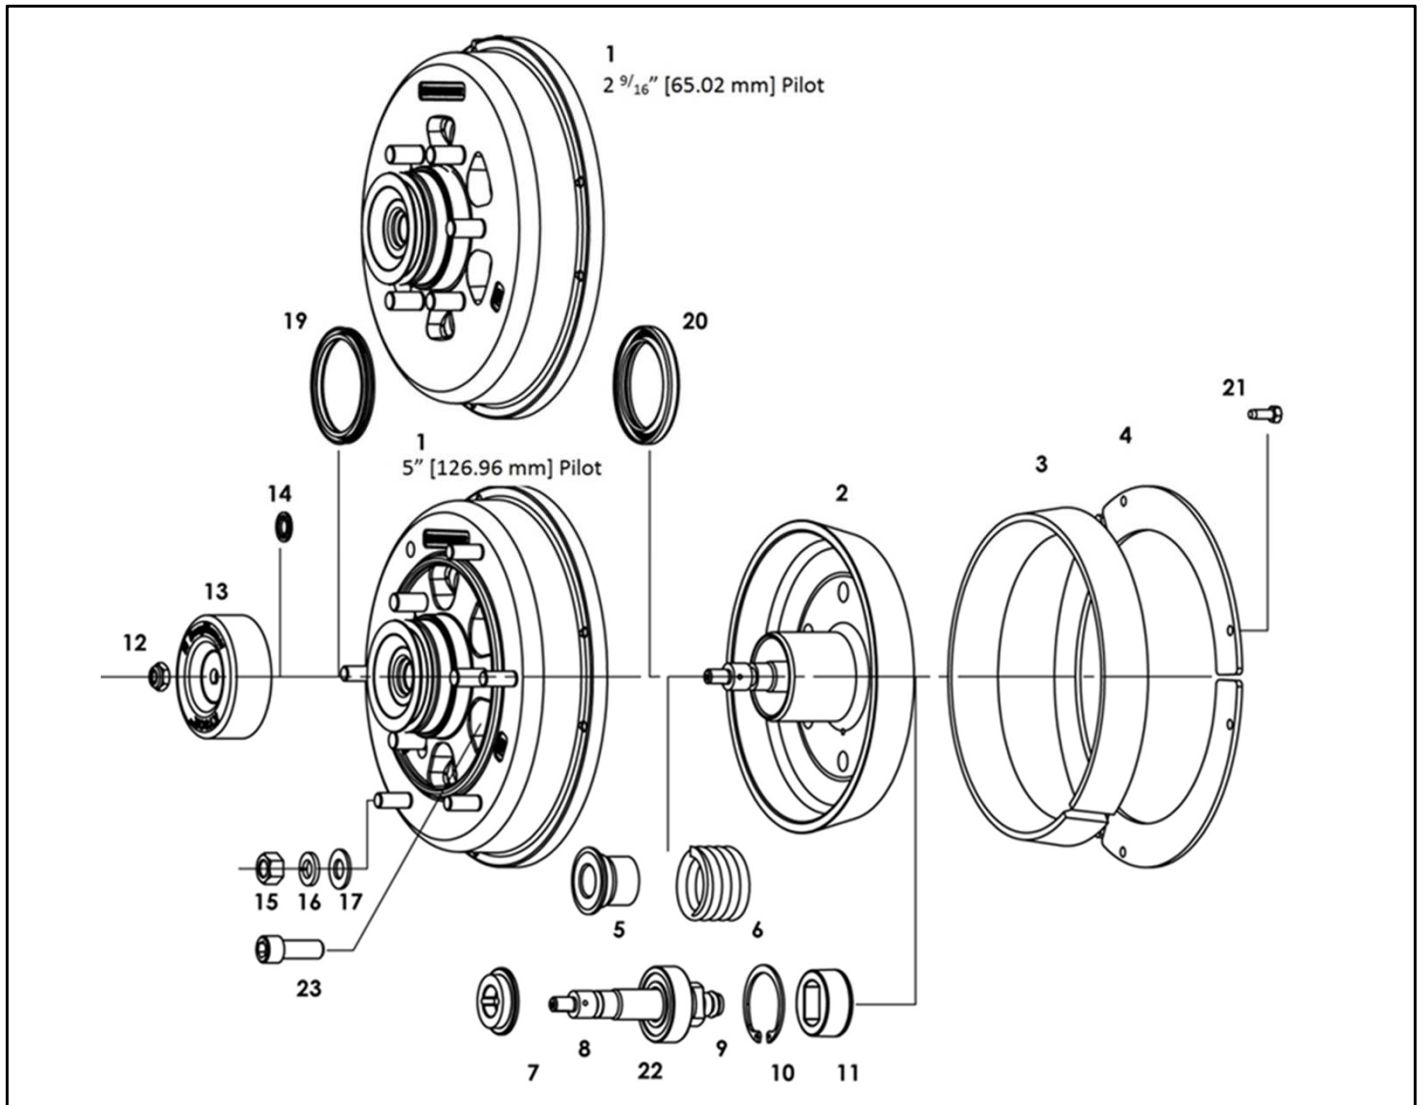
Components of the Clutch Assembly

(1) Clutch Housing; (2) Clutch Shaft; (3) Liner; (4) Retainer Plate; (5) Spring End-Cap; (6) Spring; (7) Spring Carrier; (8) Front O-Ring; (9) O-Ring at Base of Piston Rod; (10) Snap Ring; (11) Coupler; (12) 5/16" Locknut; (13) Cylinder; (14) Seal-Washer; (15) Fan Mounting Nut; (16) Fan Lock-Washer; (17) Fan Flat-Washer; (18) Fan Stud; (19) U-Cup Seal; (20) Grease Seal; (21) Retainer Plate Fastener; (22) Piston Rod and Rear Bearing Assembly; (23) Clutch Mounting Hardware

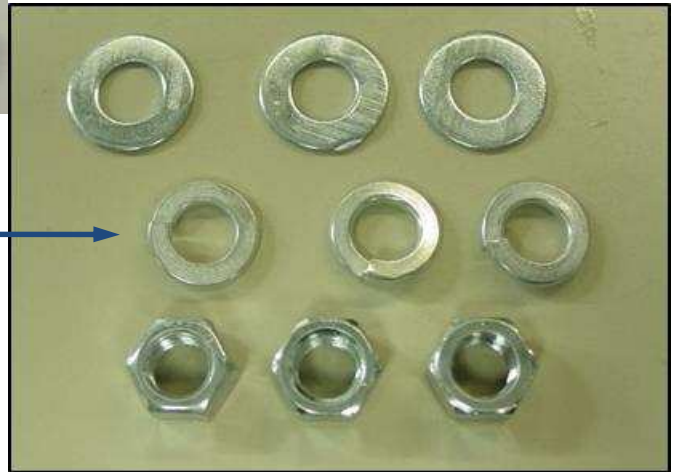
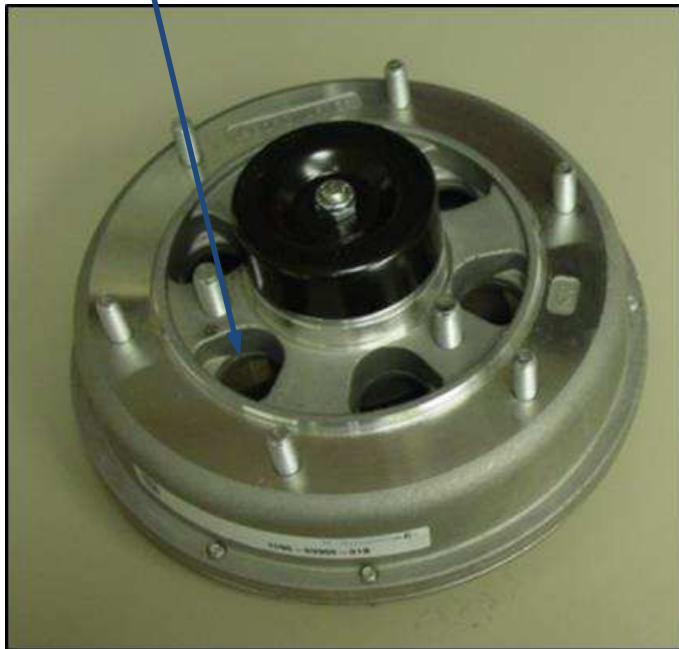
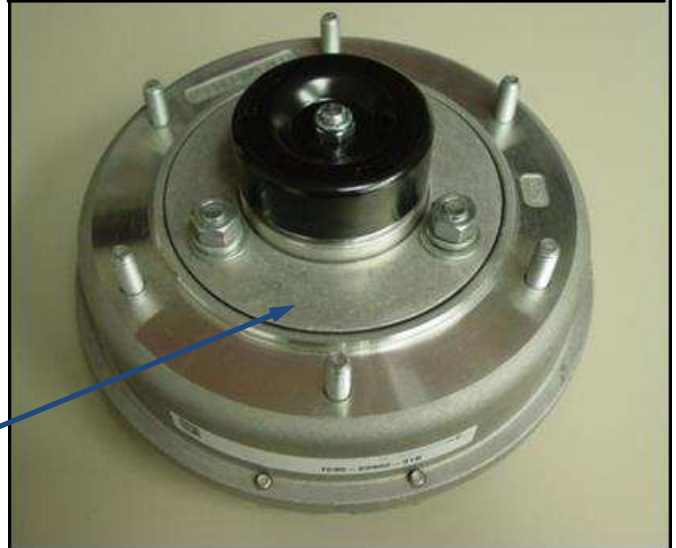
Clutch Mount
Access Holes

Hardware

Housing Cover Installed

These aluminum clutches have a 5-inch diameter fan pilot and use a housing cover to protect the inside of the clutch assembly from foreign debris. The housing cover must be removed to gain access to the clutch mounting hardware. The cover is retained by either 3 serrated flange nuts or a combination of 3 nuts, 3 lock washers and 3 flat washers.

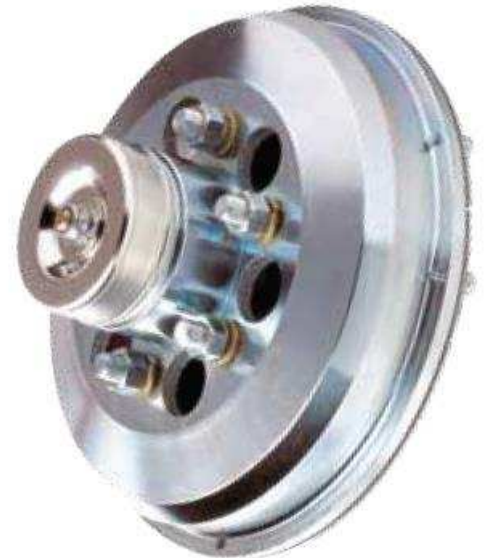
K22 Rear Air
Pictured

Part Number	Product Description
1090-08000-0xx (No Longer Available)	K22 Front Air Clutch
1090-08500-0xx (No Longer Available)	K22 Rear Air Clutch

Fan Pilot Diameter = 2 ⁹/₁₆ ”

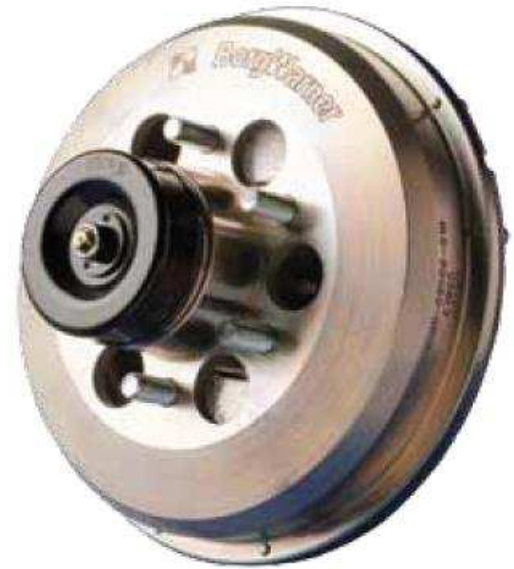
K26 Rear Air
Pictured

Part Number	Product Description
1090-09000-0xx	K26 Front Air Clutch
1090-09500-0xx (No Longer Available)	K26 Rear Air Clutch

Fan Pilot Diameter = 2 ⁹/₁₆''

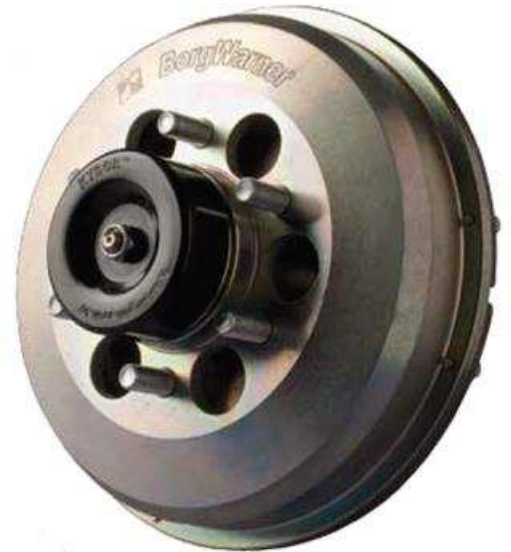
Part Number	Product Description
1090-09600-0xx	K30 Steel Rear Air Clutch

Fan Pilot Diameter = 2 ⁹/₁₆''

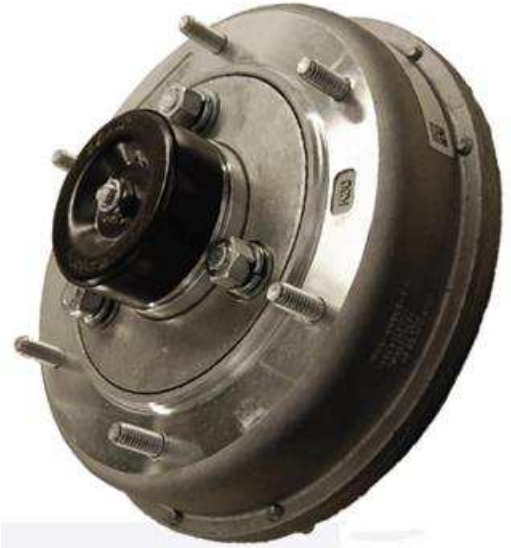
K30 Aluminum
With 5" Fan Pilot Pictured

Part Number	Product Description*
1090-09800-0xx (No Longer Available)	K30 Aluminum Rear Air Clutch 2 9/16" Diameter Fan Pilot
1090-09900-0xx (No Longer Available)	K30 Aluminum Rear Air Clutch 5" Diameter Fan Pilot

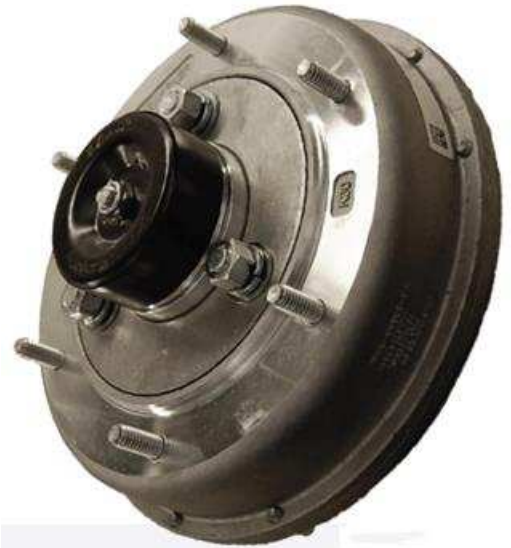
K32 Aluminum
With 5" Fan Pilot Pictured

Part Number	Product Description*
1090-09850-0xx (No Longer Available)	K32 Aluminum Rear Air Clutch 2 ⁹ / ₁₆ " Diameter Fan Pilot
1090-09950-0xx (No Longer Available)	K32 Aluminum Rear Air Clutch 5" Diameter Fan Pilot

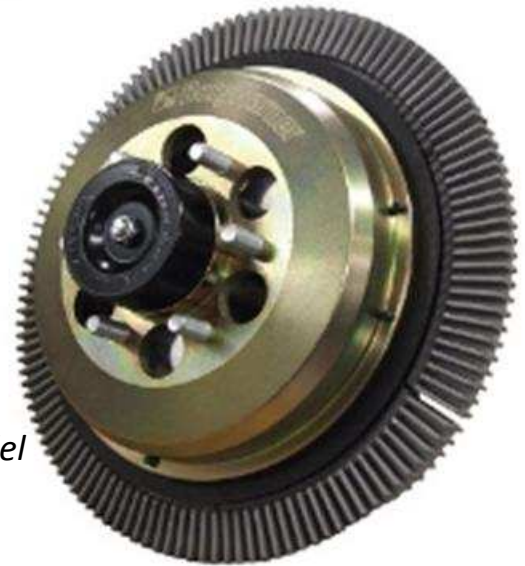
Part Number	Product Description*
1090-29650-0xx	DuroSpeed™ Rear Air 2 speed Clutch - 2 9/16" Diameter Fan Pilot
1090-29750-0xx	DuroSpeed™ Rear Air 2 speed Clutch - 5" Diameter Fan Pilot

Note: the DuroSpeed™ clutch may not fit on some pre model year 2007 vehicles. Verify clearance for all rotating parts.

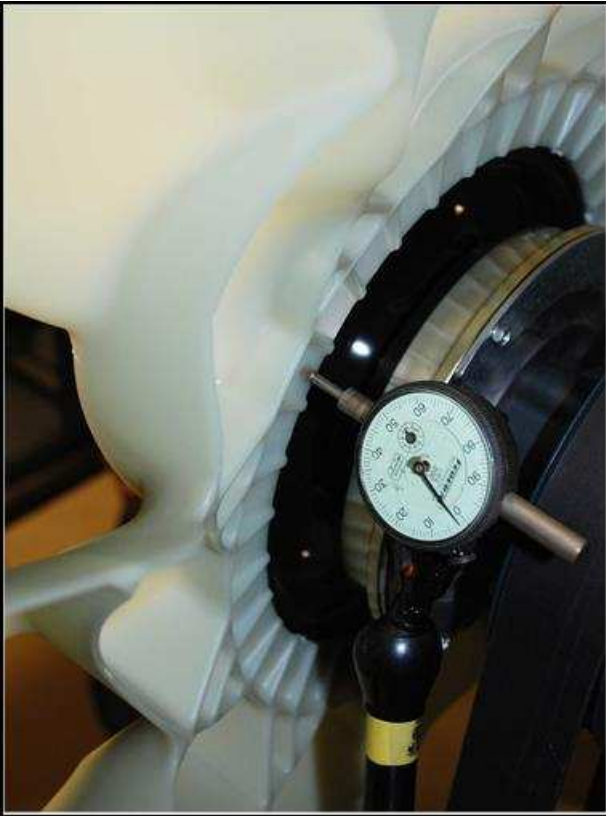
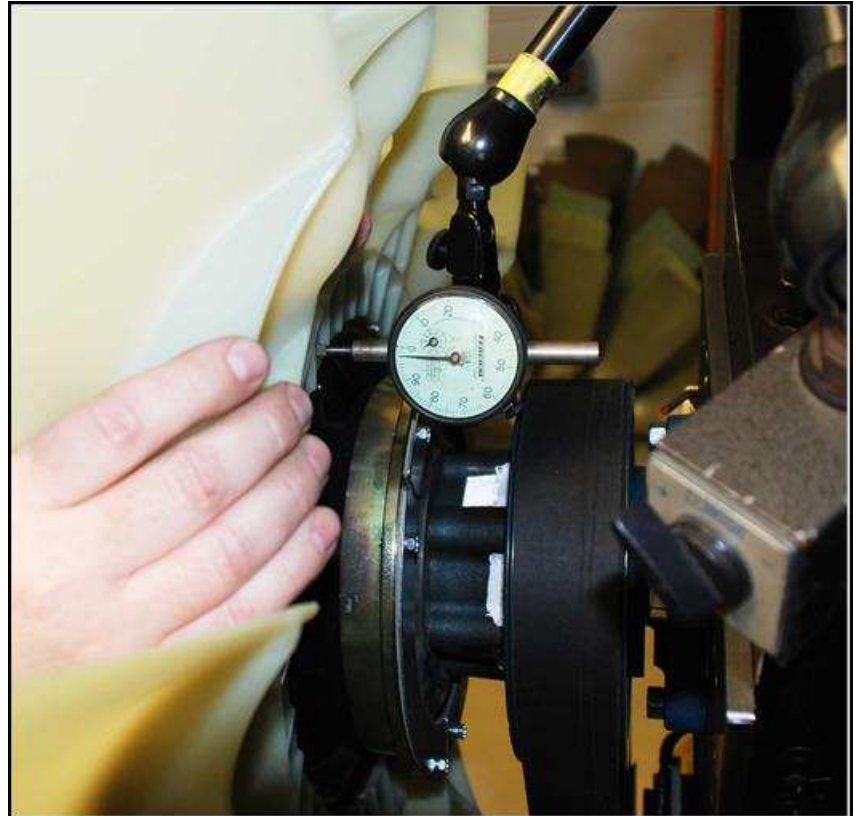
Inspecting the Clutch Assembly for Play

Supply 90-110 PSI air pressure to the fan drive to disengage the clutch. Setup a dial indicator on a flat rear surface of the fan, very close to the outer rim of the clutch (see the image to the upper left).

Grasp the fan as close to the position of the dial indicator as possible (see the image to the upper right). Gently move the fan forward and rearward (do not force), and record the total indicator reading.

If the total indicator reading exceeds 0.050" (1.27mm) then the clutch should be replaced. If the total indicator reading is less than or equal to 0.050" (1.27mm) then the amount of clutch play is acceptable.

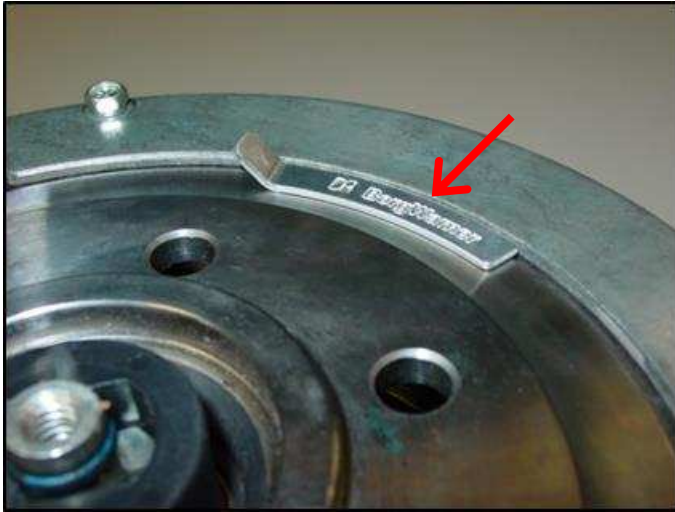
Liner Life Remaining

Remaining liner life may be checked by using the Service Alert Tool. This tool is available for no cost at www.borgwarner.com/thermallit.

Start with the clutch engaged (no air pressure to the drive). Place the Service Alert Tool flush against the rear face of the clutch shaft as shown in the images above (this may be done with the clutch installed on the vehicle).

If the Service Alert Tool sits below the surface of the retainer plate (as shown in the image on the left) then the liner has life remaining. If the Service Alert Tool sits above the surface of the retainer plate (as shown in the image on the right) then the liner should be replaced as soon as possible. See Pg 26 to determine whether a control system issue is responsible for rapid liner wear.

Note: the Service Alert Tool has a thickness of 0.062" – if the Service Alert Tool is not available, then the liner should be replaced when the clutch shaft's rear face is less than 0.062" forward of the retainer plate's rear face.

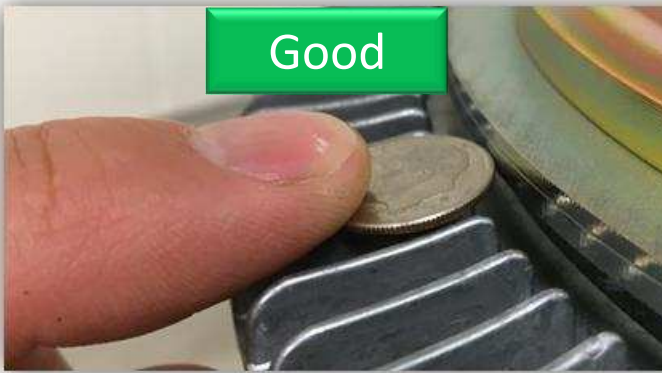
Liner Life Remaining

Remaining liner life may be checked by using a United States Dime.

Start with the clutch engaged (no air pressure to the drive). Place the United States Dime against the cooling fins of the flux ring as shown in the pictures above.

If the United States Dime slides **AGAINST** the outer edge of the lining retaining ring then the liner has remaining life. If the United States Dime slides **UNDERNEATH** the lining retaining ring then the lining should be replaced as soon as possible. See Pg 26 to determine whether a control system issue is responsible for rapid liner wear.

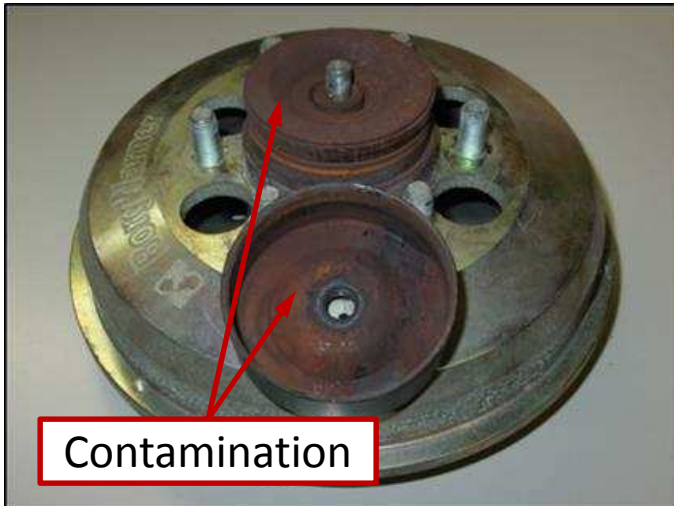
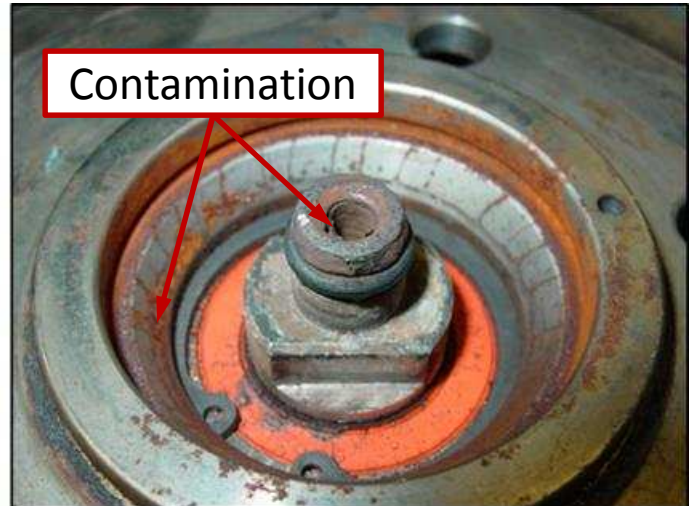
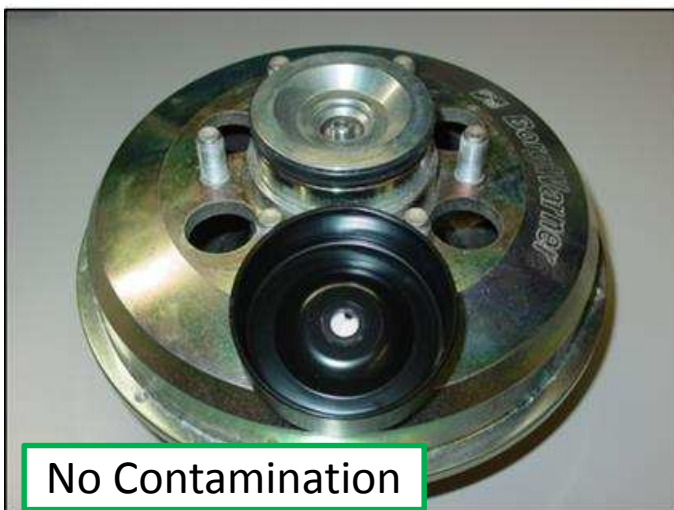
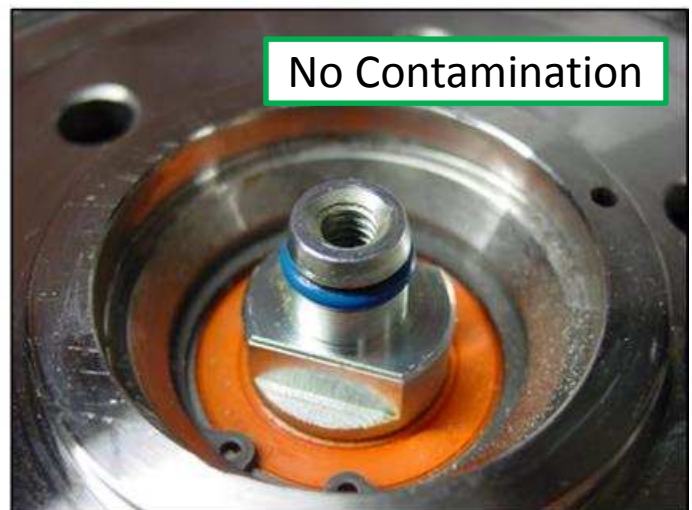
Air System Contamination

Disassembly of the clutch is not required - images are provided for reference only. Contamination in the air system may cause air seal leaks, operation troubles, or clutch failure. **Any failure due to air system contamination is not warrantable through BorgWarner.**

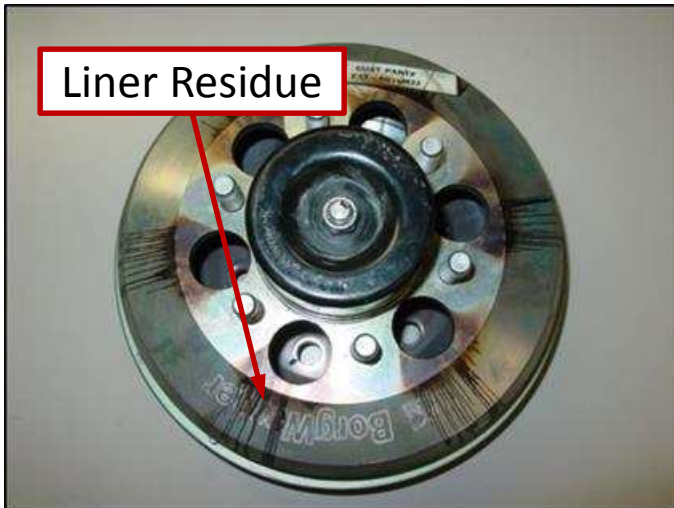
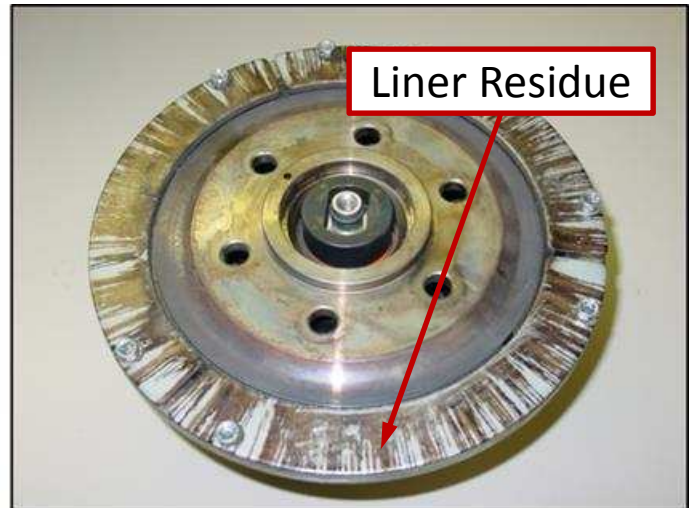
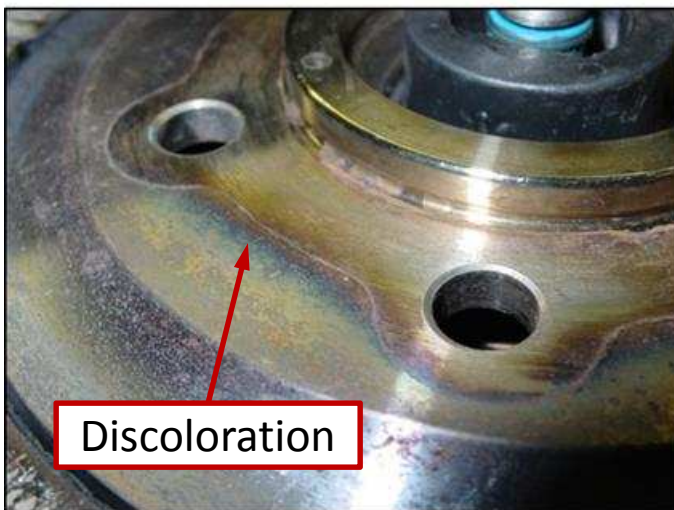
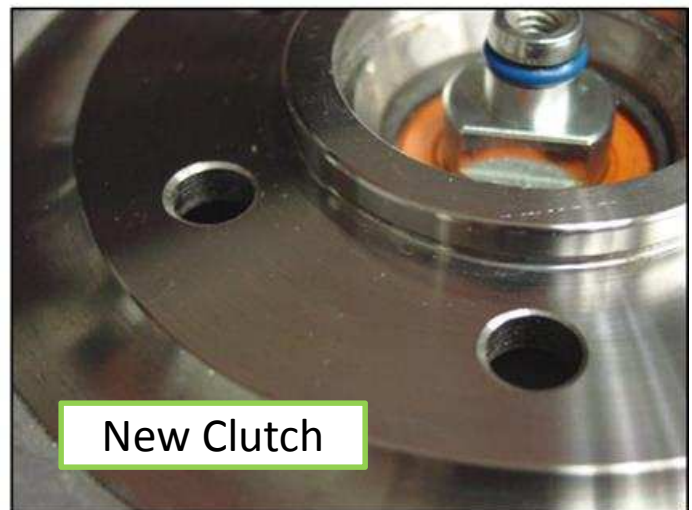
Control System Issue

A control system issue (potential root causes identified on Pg 27) or restricted fan rotation may cause the clutch to overheat and ultimately fail. Evidence of an overheated clutch includes liner residue on the forward and/or rear face of the clutch, discoloration of the rear face of the clutch, an extremely worn liner, or even a melted coupler. **Any failure due to a control system issue is not warrantable through BorgWarner – check with the OEM for possible warranty coverage.**

Control system issues, which may cause the clutch to wear excessively or overheat, include any of the following root causes:

- Incomplete clutch disengagement (liner still in contact) due to air pressure below 90 PSI. Verify that air pressure at the hub fitting is 90-110 PSI when the clutch is disengaged.

- Slow clutch disengagement due to a low air flow rate caused by a contaminated air solenoid, pinched air line, air leak, or high air demand. Verify that air pressure at the hub fitting increases almost instantaneously from 0 PSI to at least 90 PSI (in less than 1 second).

- Slow clutch disengagement or incomplete clutch disengagement due to insufficient air pressure or insufficient air flow rate ultimately caused by vehicle electrical issues. Verify that air pressure at the hub fitting increases almost instantaneously from 0 PSI to at least 90 PSI (in less than 1 second).

- Slow clutch engagement due to a plugged air vent, a contaminated air solenoid, or a pinched air line (air pressure must be released quickly to engage clutch with minimal slippage). Verify that air pressure at the hub fitting decreases almost instantaneously from more than 90 PSI down to 0 PSI (in less than 1 second).

- Frequent clutch (and fan) engagements lasting less than 30 seconds (clutch over-cycling) due to the lack of a fan “on-time” timer within the engine or vehicle control module, A/C problems, or defective control system.

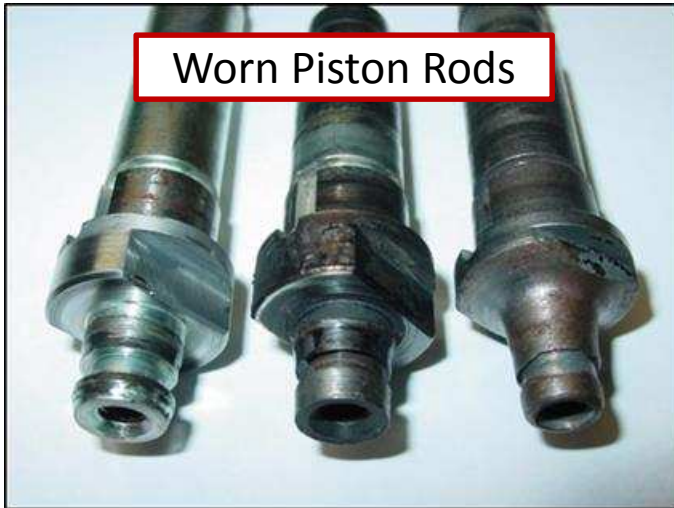
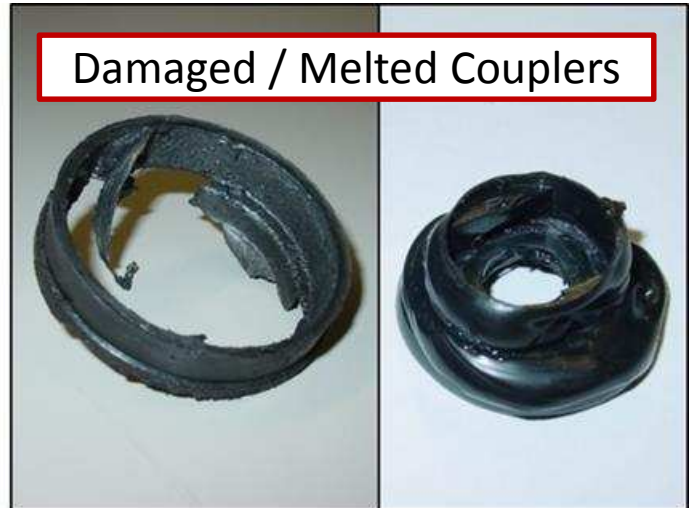
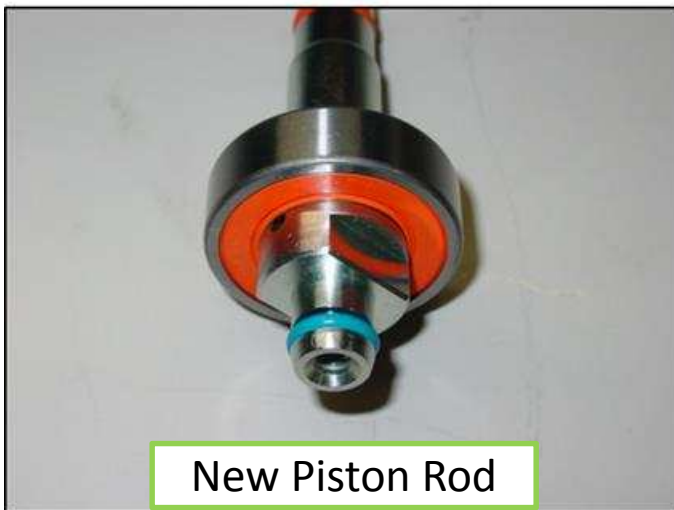
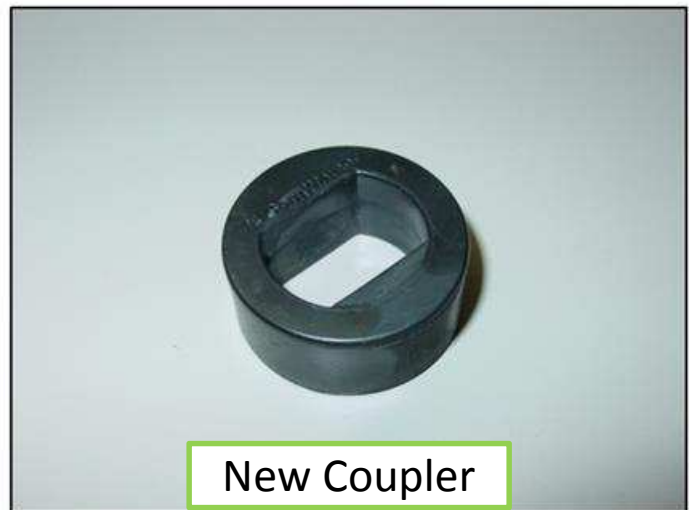
Indications of Pulley Bearing (Hub) Problems

Damage to the base of the piston rod or o-ring; a rounded out or melted coupler may be caused by pulley bearing problems. Inspect for play or rough motion in the pulley bearings (See Pg 16). **If a clutch is damaged by pulley bearing problems, and the hub is still under warranty, then both the clutch and hub must be returned to BorgWarner for warranty consideration.**

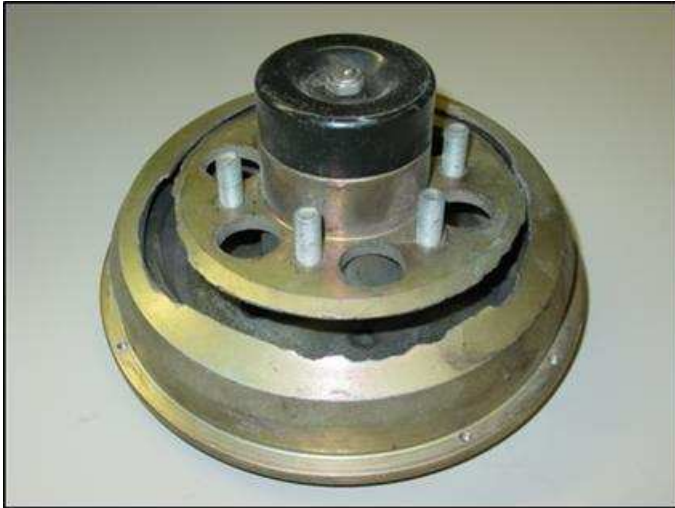
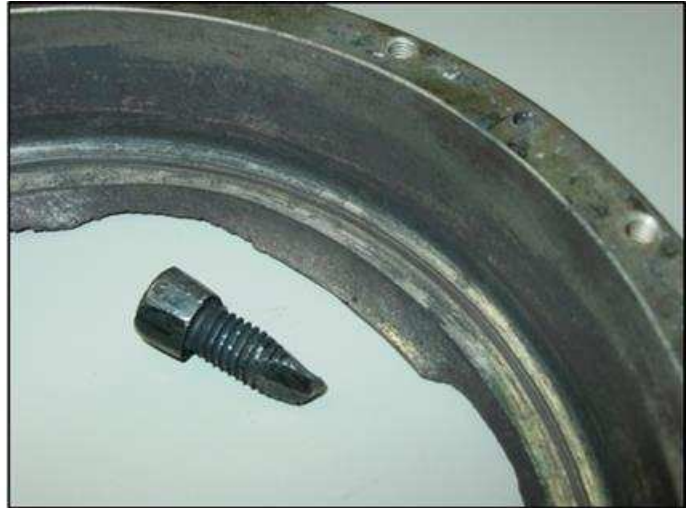
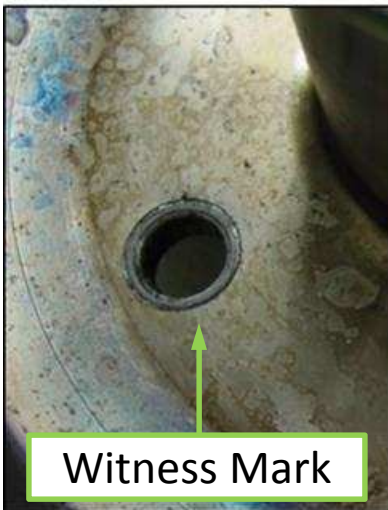
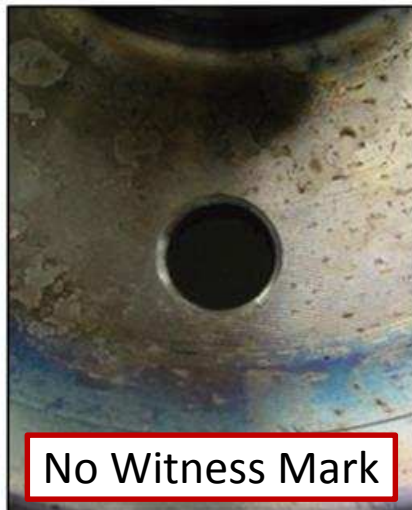
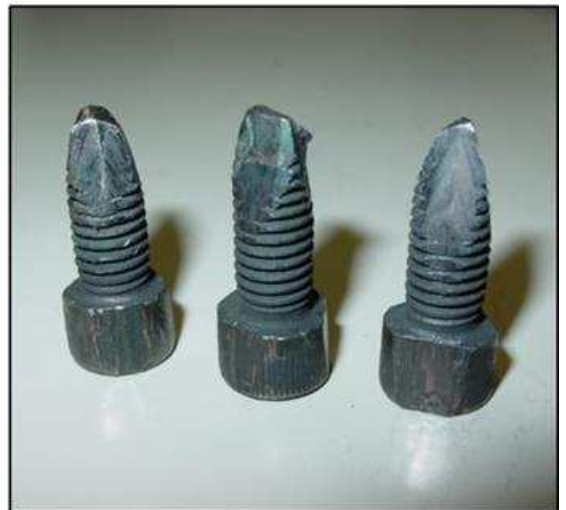
Improper Installation

Any extra bolts left loose inside the clutch housing will cause internal damage during clutch operation. Any of the 6 clutch mounting bolts that are not torqued to 45 lbf-ft (61 Nm) may become loose inside the clutch housing and cause internal damage. Bolts that are properly torqued will leave a witness mark in the clutch shaft. **A failure due to improper installation is not warrantable through BorgWarner, unless the failure occurred on an original equipment factory installation.**

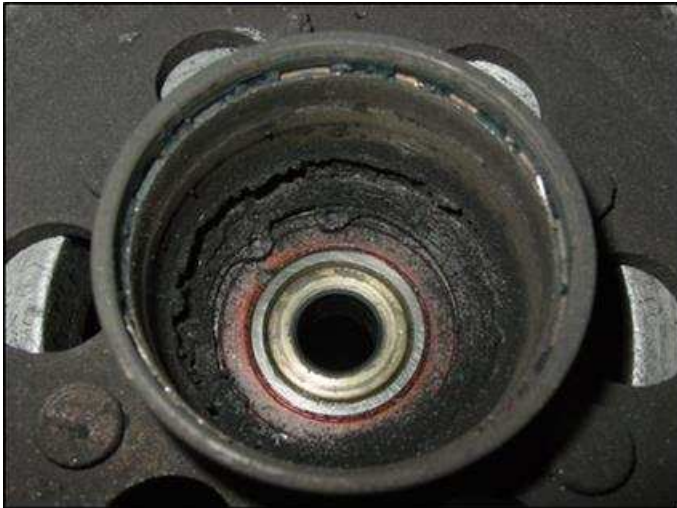
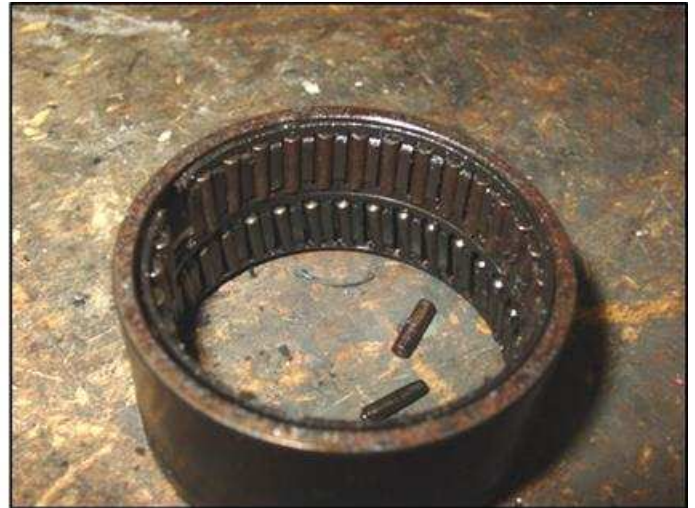
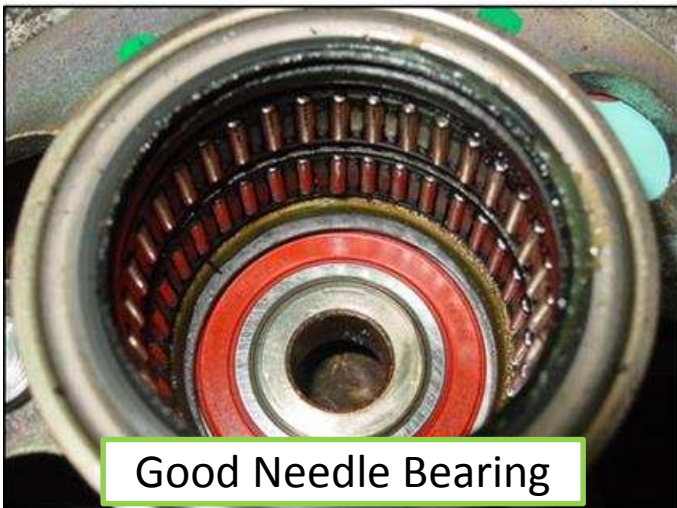
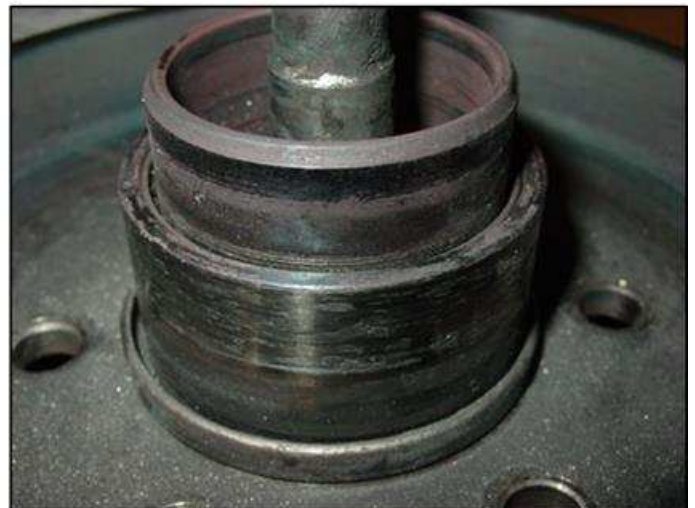
Needle Bearing Failure

Disassembly of the clutch is not required - images are provided for reference only. Needle bearing problems are rare, but can occur. **If a needle bearing fails due to a hub failure (see Pg 28), and the hub is still under warranty, then both the clutch and hub must be returned for warranty consideration.** If a needle bearing fails without a hub failure, then the clutch alone may be returned for warranty consideration. A needle bearing failure due to a defect in material or workmanship is warrantable through BorgWarner.

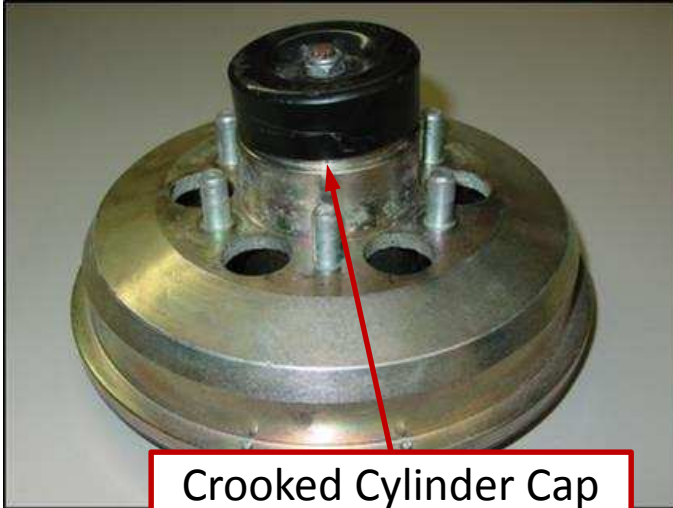
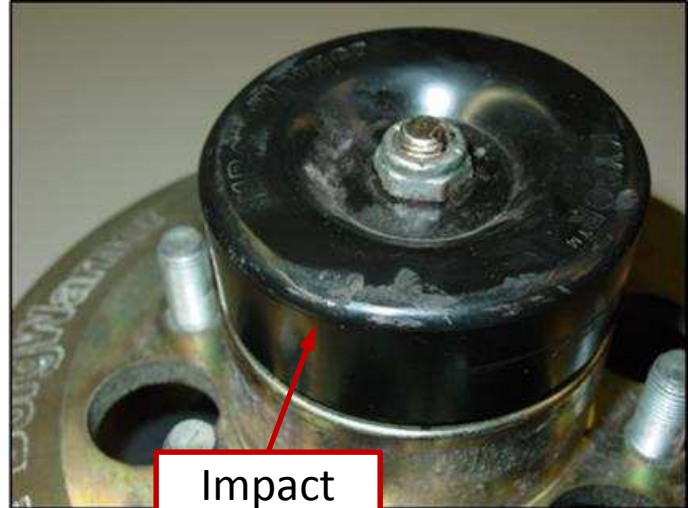
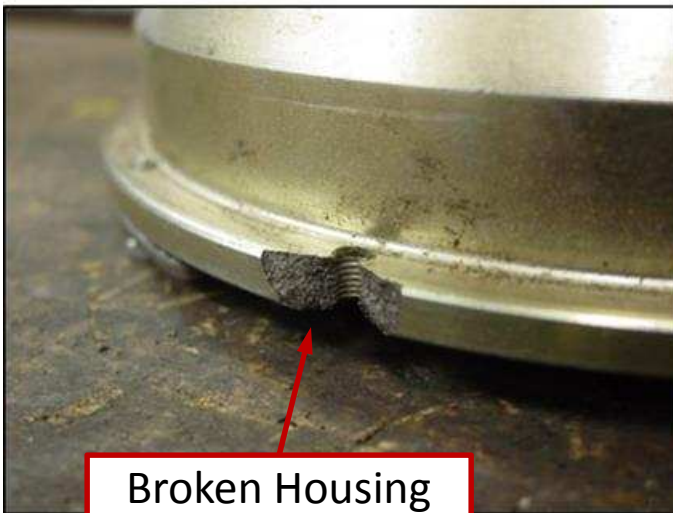
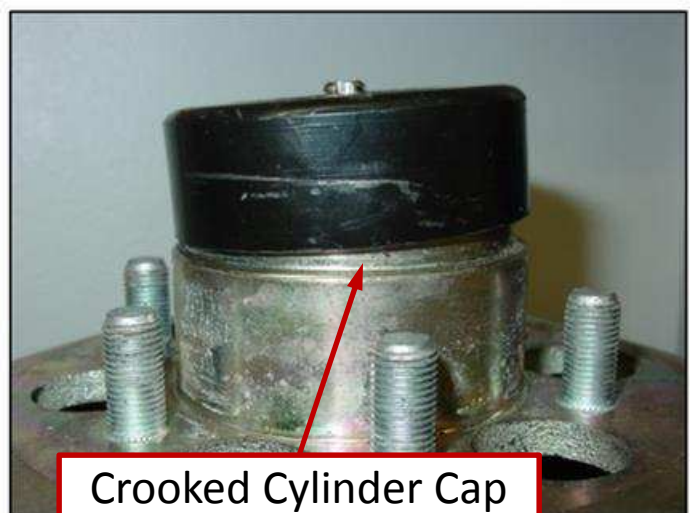
Physical Damage

An impact to the cylinder cap may bend the piston rod (which carries the cylinder cap) and produce an air seal leak. The bent piston rod may even prevent the clutch from engaging or disengaging. An impact to the clutch housing, especially near a fastener hole, may fracture the housing and cause a fastener to become loose or lost. **A failure due to physical damage of any kind is not warrantable through BorgWarner.**
